# Carpenter Drain Design/Build Report

Steuben County, Indiana

June 20, 2005

## **CARPENTER DRAIN DESIGN/BUILD REPORT EXECUTIVE SUMMARY**

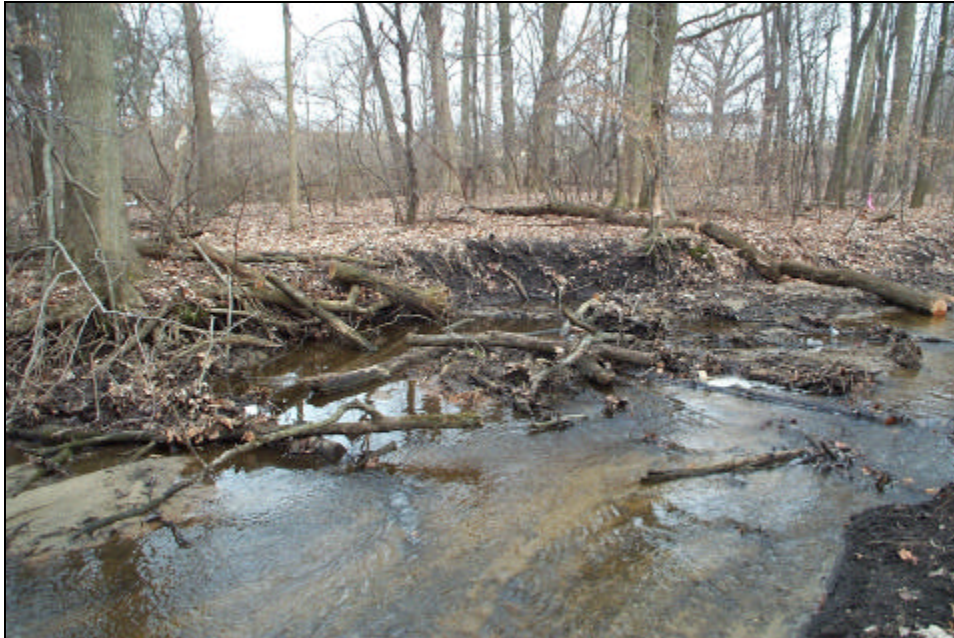
not uniformly steep throughout the entire reach. In places of moderate to severe erosion, they average 3-4 feet in height. The streambank erosion is likely due to anthropogenic impacts (increased non-permeable surfaces, stream channelization, etc.) within Carpenter Drain's watershed. As a result of these impacts, increased water velocity and peak flows have created additional shear stress along the streambanks. Large pieces of debris located within the stream also deflect the water's force toward the streambanks scouring the bank in several places. In some instances, the input of woody debris into the stream can be attributed to streambank failure and the subsequent collapse of trees along the bank. Figure 2 shows a representative photograph of streambank erosion occurring within the project site.

**Figure 2. View of typical streambank erosion occurring within the project area.**

The purpose of this project was to reduce sediment and sediment-attached pollutant delivery to Crooked Lake. This was accomplished by stabilizing the moderate to severely eroded streambanks with bioengineering techniques within the project area. Large pieces of debris, such as old culvert pipes and cross channel logjams, which were deflecting stream flows into the bank were also removed.

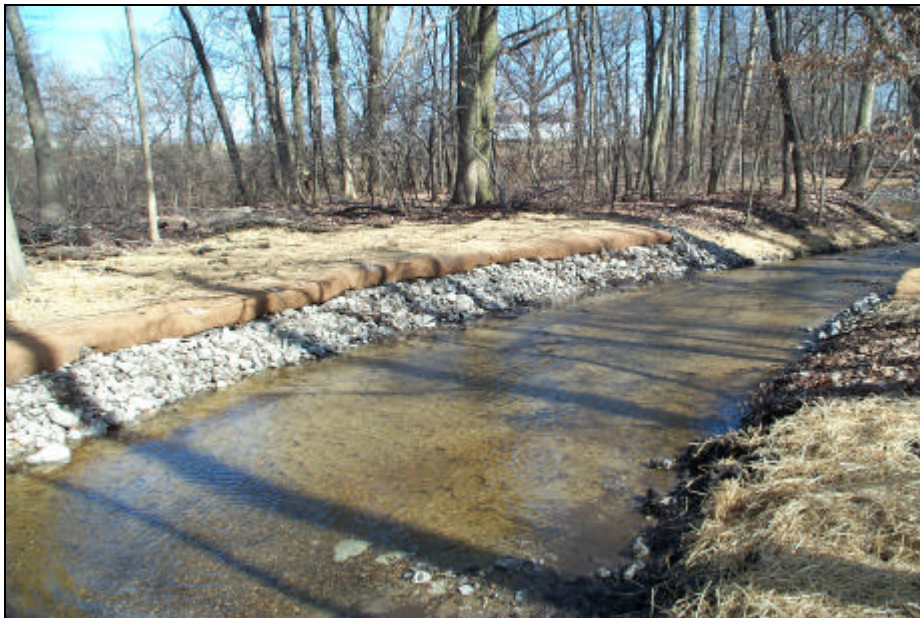
A non-woven geotextile blanket was placed on top of the rock to prevent soil from being washed out from under the soil encapsulated lifts. Prefabricated lift forms were then placed on top of the

rock foundation and non-woven geotextile blanket. Bare root silky dogwood (*Cornus amomum*) shrubs were placed beneath the forms with the tops protruding out towards the stream. The silky dogwood root masses were then covered with soil. A roll of heavy, woven coconut fabric blanket (Dekowe) was rolled out over the forms parallel to the shoreline. Approximately two feet of the blanket overlapped the prefabricated lift forms landward while the remaining width of blanket hung out towards the stream. Soil was placed in the void between the lift forms and streambank, compacted by hand, and then planted along the exposed faces with a wooded wetland seed mix. (See Appendix C for seed mix species.) The fabric extending out towards the stream was then folded back over the compacted soil and secured in place with oak stakes and six-inch metal sod staples. The fabric was keyed in along the tip of the slope to prevent soil and seed from being washed from under the blanket. The prefabricated lift forms were then removed. This procedure was repeated as necessary until the lift(s) matched the grade along the top of the bank slope. Figure 4 shows a typical completed soil encapsulated lift structure along the Carpenter Drain project area. In this case, only a single lift was needed to match the surrounding landscapes grade.

**Figure 4. Typical view of streambank stabilization on the Carpenter Drain project site.**

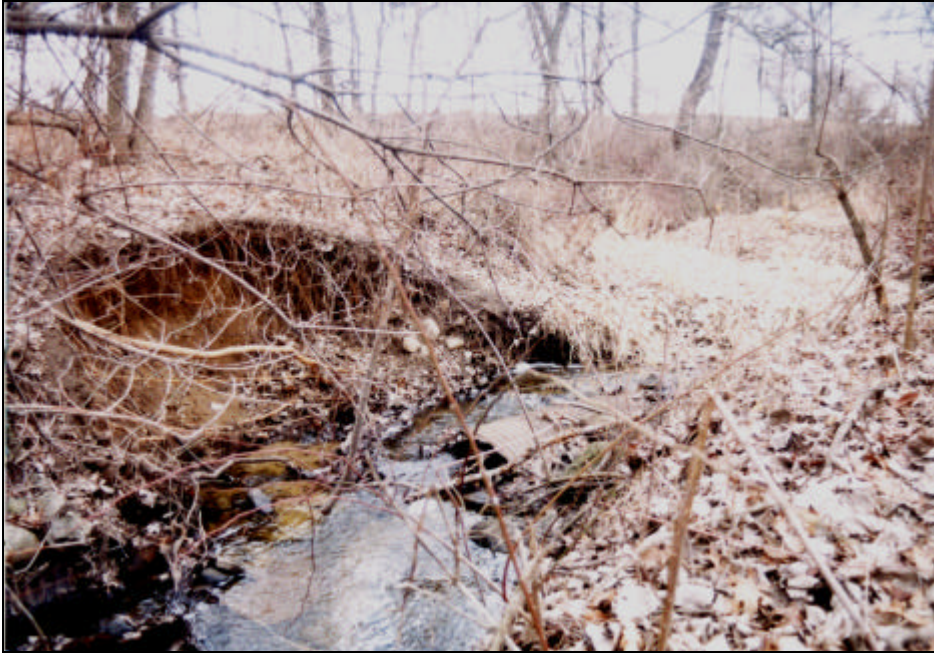
Figure 1. Streambank erosion occurring at former stream crossing of Carpenter Drain at Site 1.

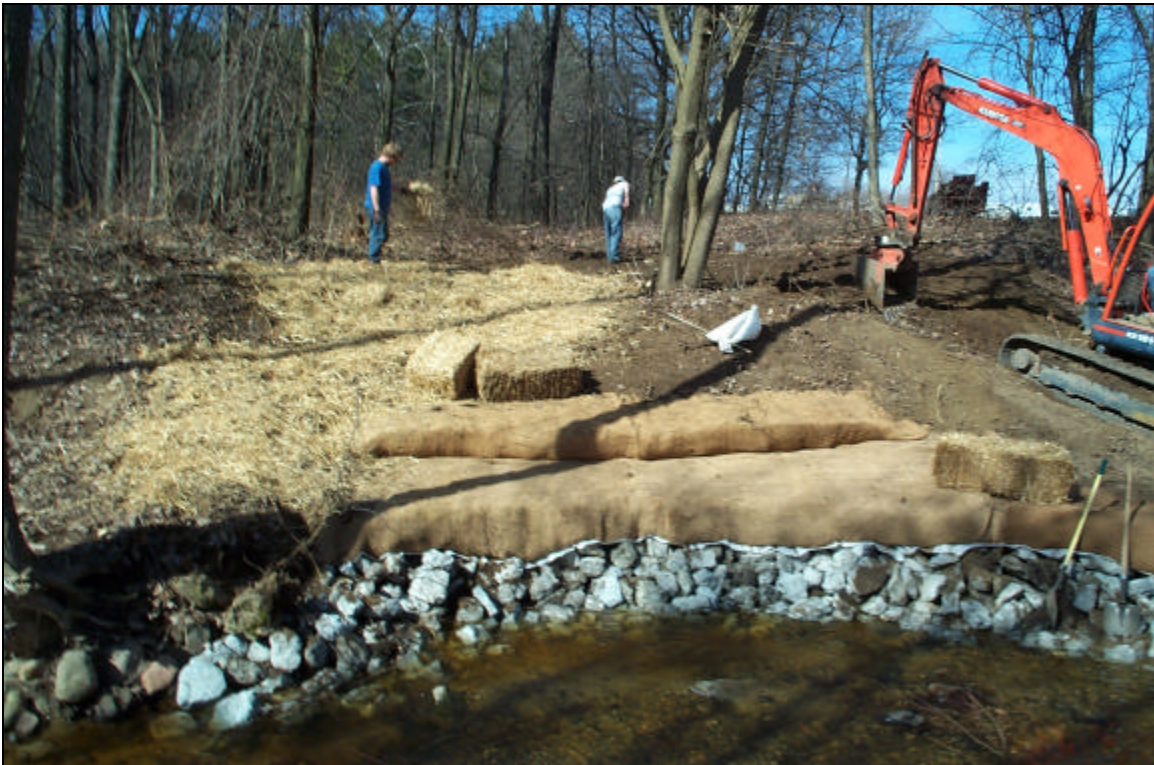
Figure 2. Soil encapsulated lifts constructed at Site 1. The earthen mound used in the old crossing has been regraded to match the existing floodplain grade.

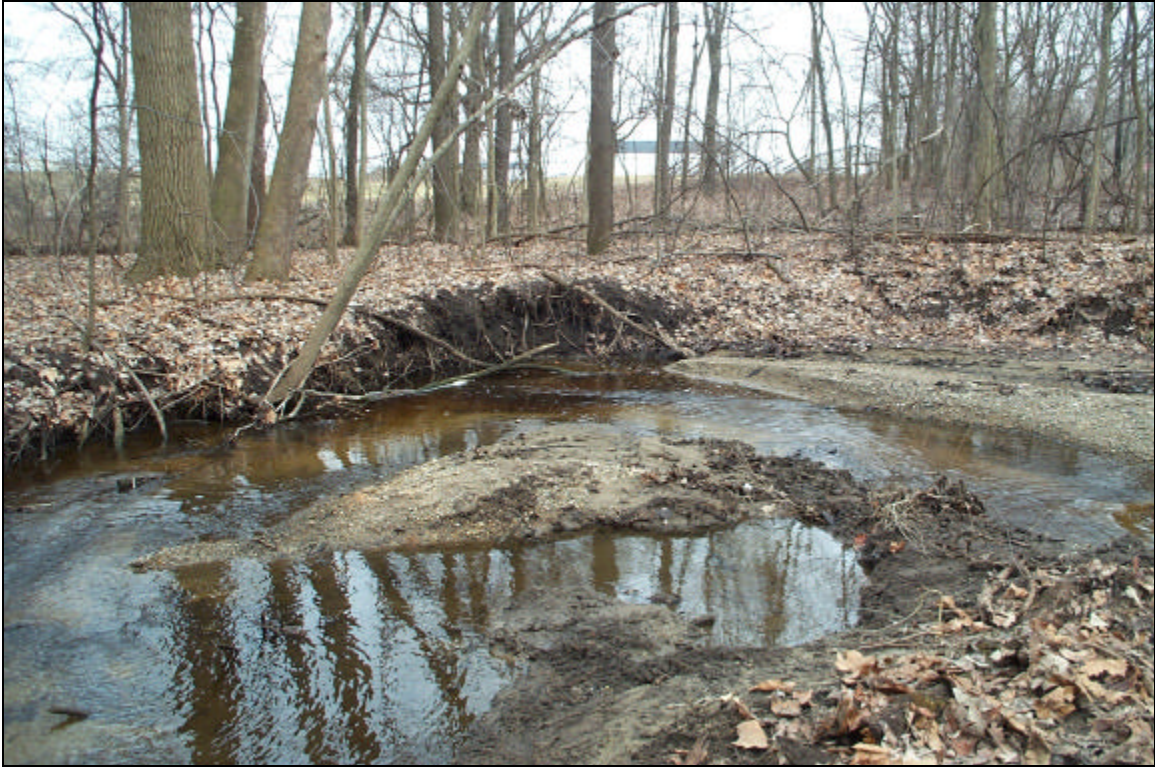
Figure 3. Upstream view of erosion occurring on the outside bend of Site 2.

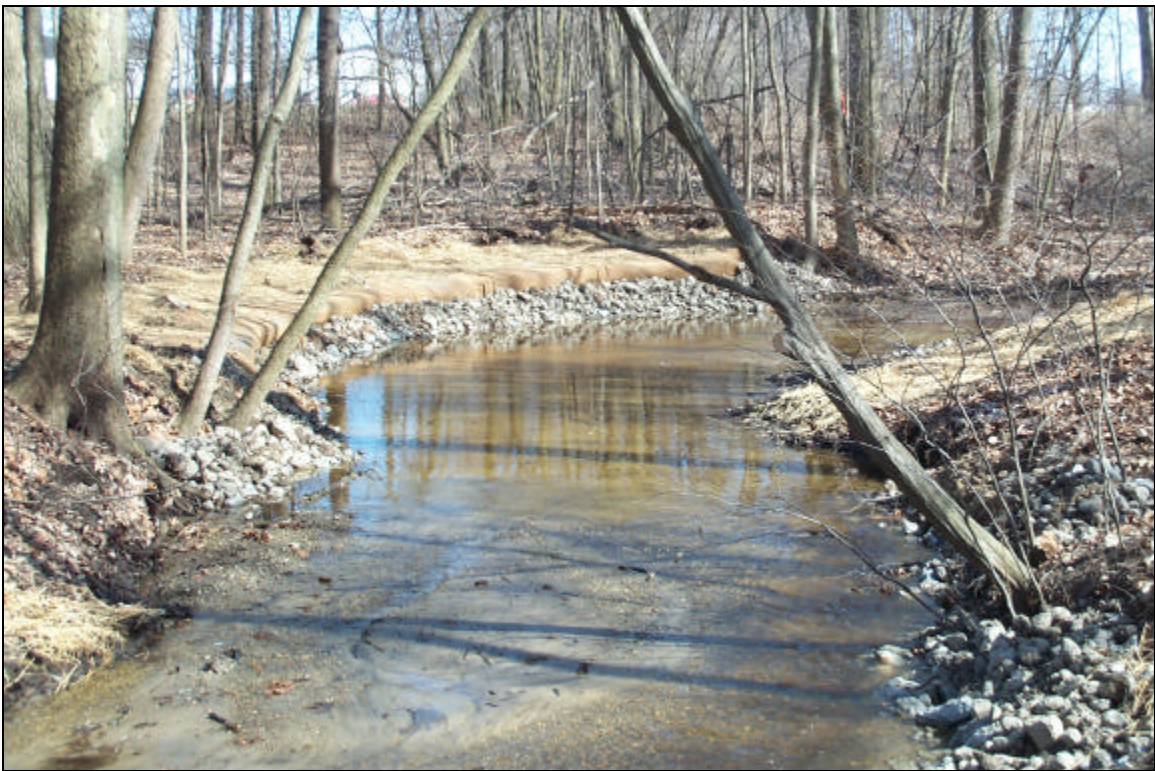
Figure 4. Upstream view of Site 2 after the installation of a soil encapsulated lift.

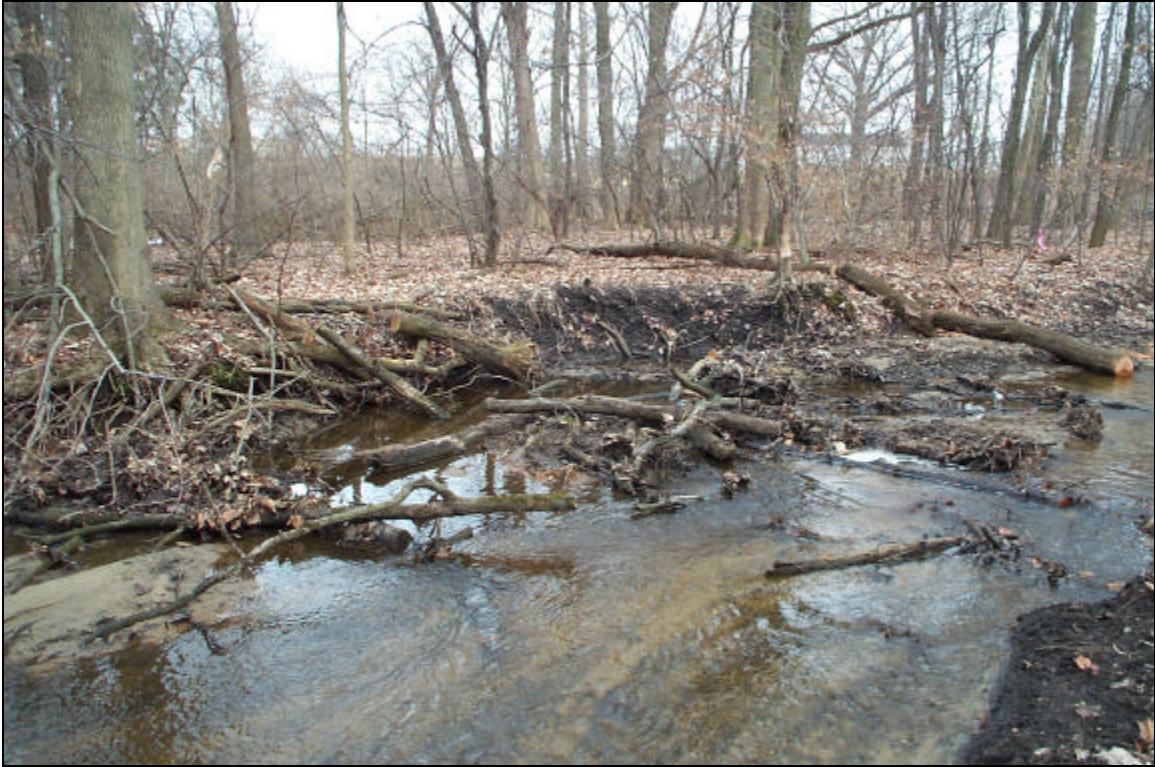
Figure 5. Upstream view of streambank erosion occurring at Site. Note the felled trees that JFNew crews have begun to cut up for removal. These trees force stream flows into the bank during high flow events leading to erosion.

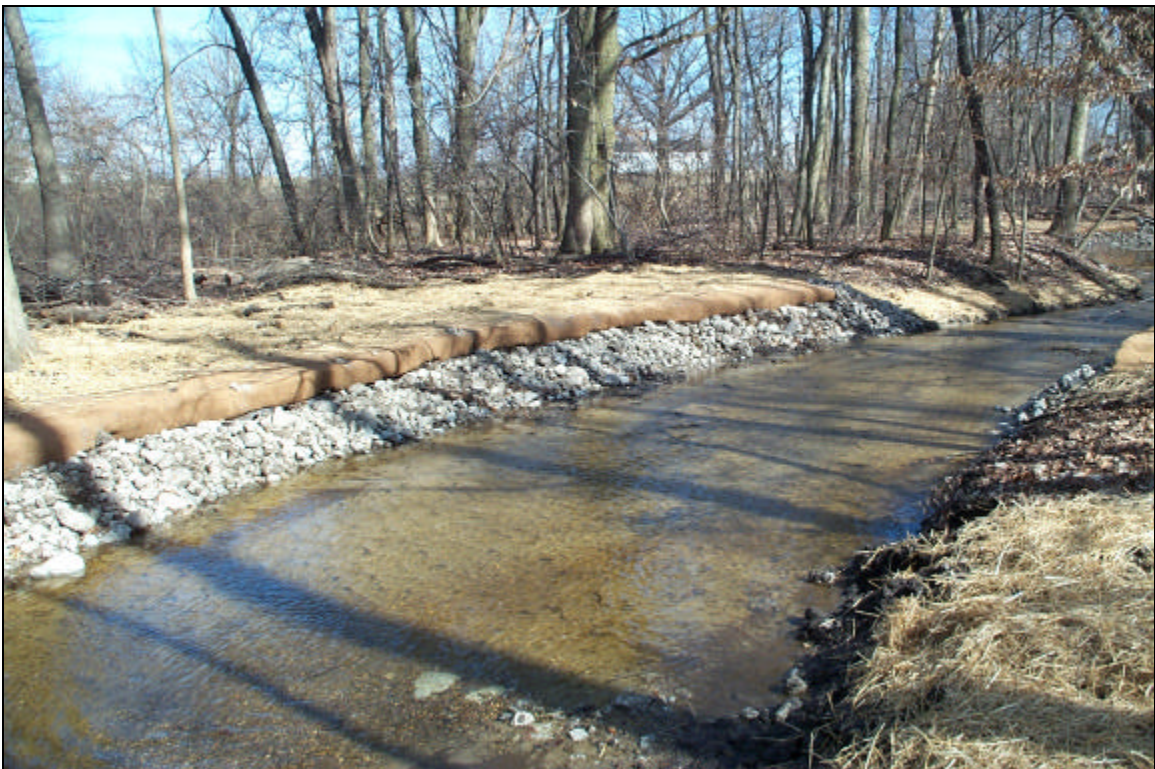
Figure 6. Upstream view of Site 3 after soil encapsulated lift construction.
